Walk Around

F-8 Crusader

Walk Around Number 38
squadron/signal publications

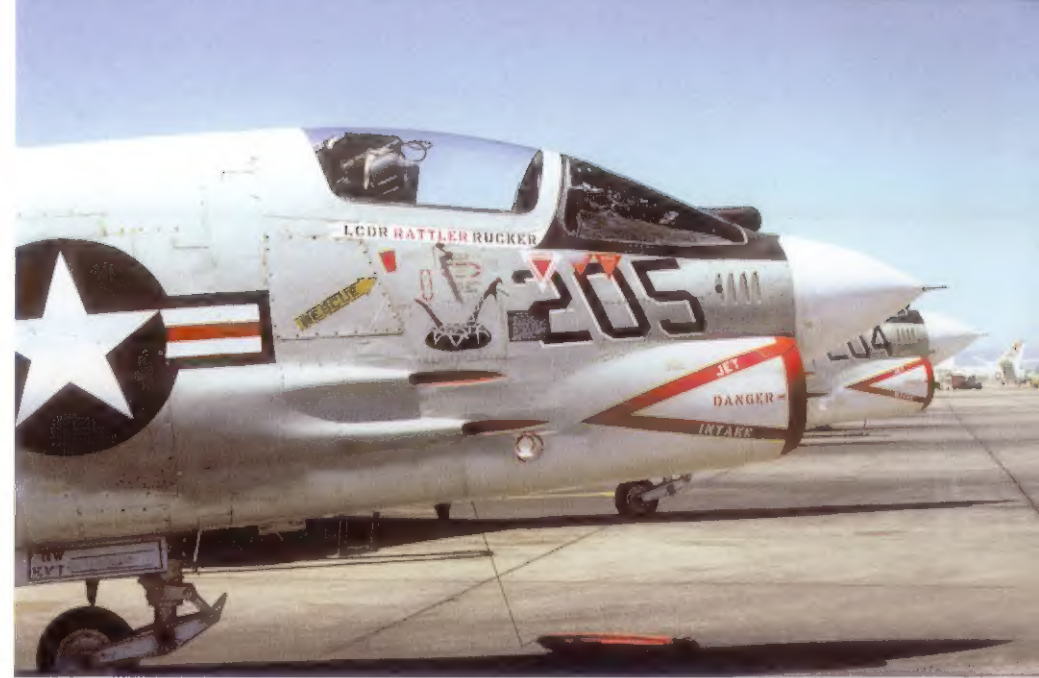
This F-8H's nose profile shows the uneven taper of the upper and lower nose cone surfaces. This resulted from the oval cross section at the fuselage to nose cone interface. The early style flat pitot tube was retained on the F-8H after remanufacture, along with three small cooling vents for the radar system. (Detail & Scale)

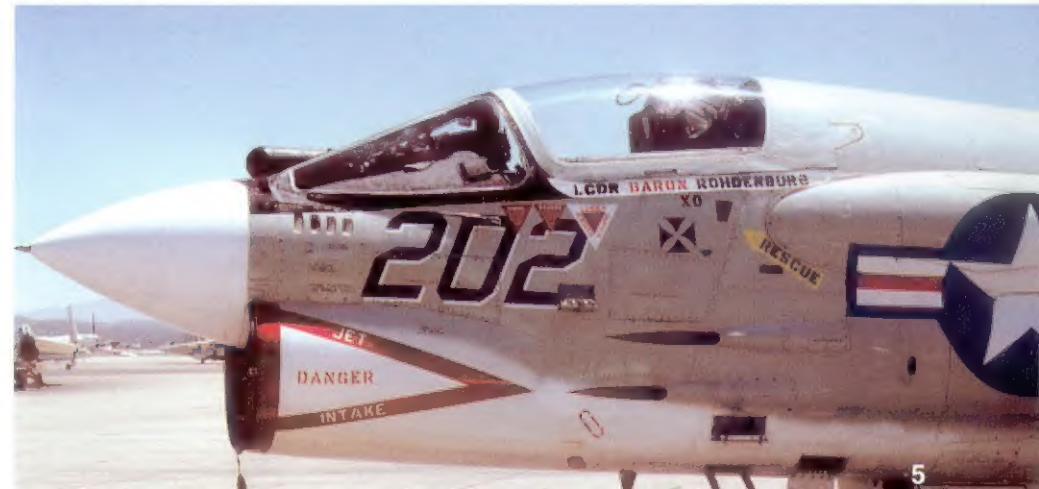
The F-8E/J's right nose side had four cooling vents, as did previous variants. The vents' shape differed on the F-8E/J, which resulted from the tapered fairing required to blend the larger diameter radome to the fuselage. (Trombecky)

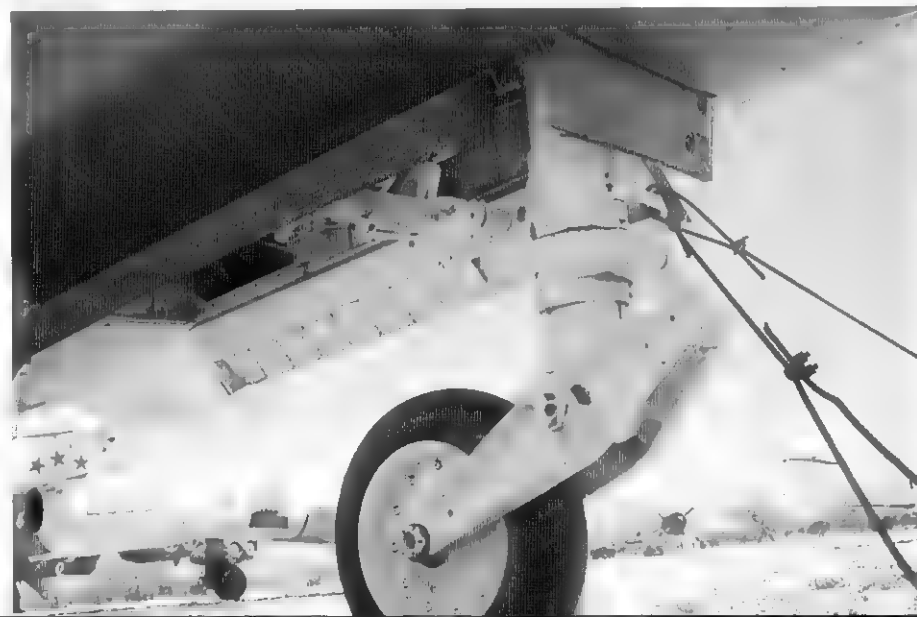
The second style nose wheel was introduced on the F8U-2N (F-8D) variant. It was made of a solid aluminum casting that replaced the earlier spoked design. This solid style wheel replaced the spoked wheel on earlier Crusaders as they were processed through routine maintenance. A mooring tie down loop was located at the main gear shock strut's front section. (Rough)

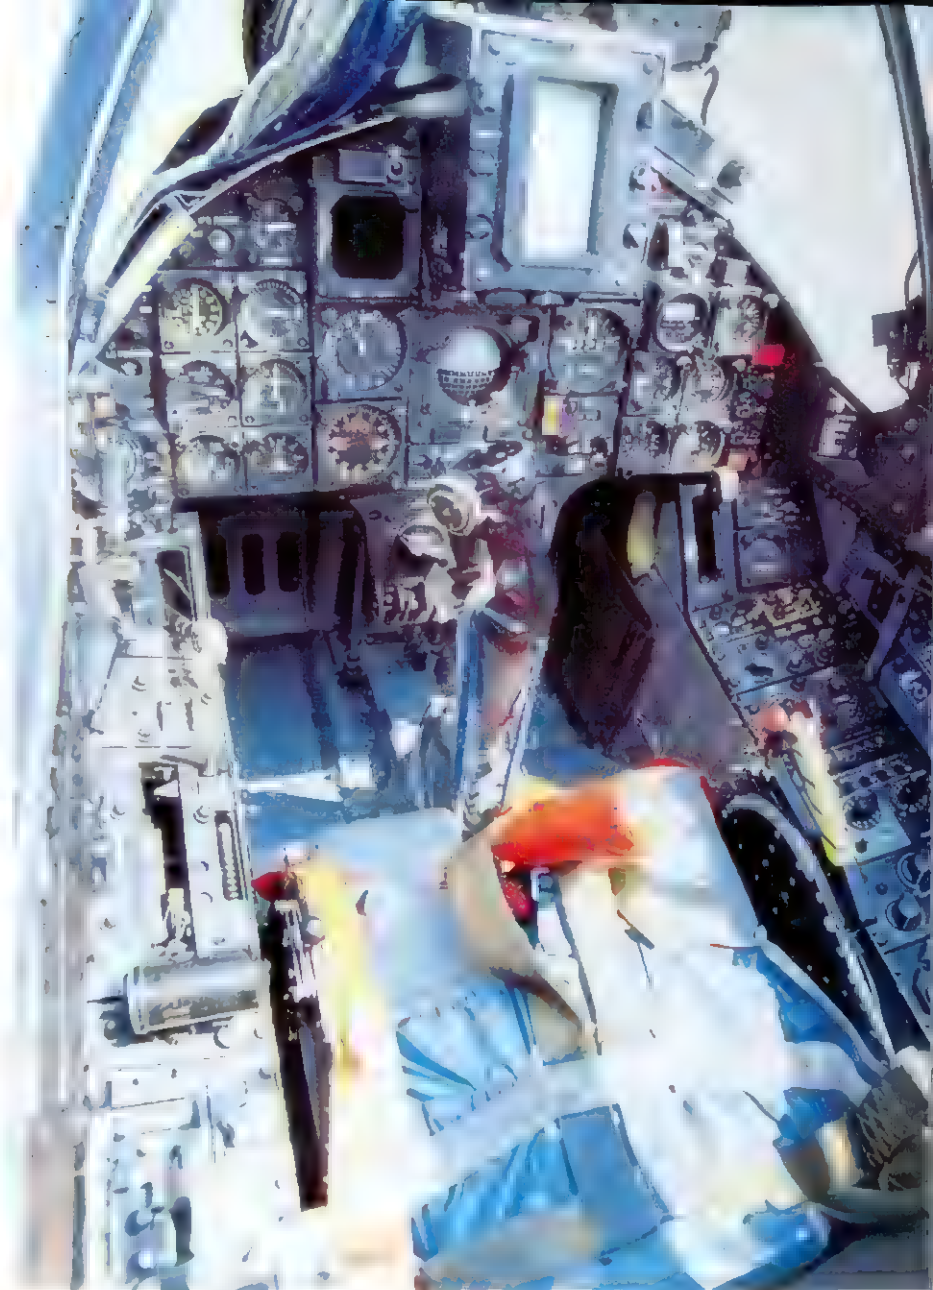
The F-8E (FN) P cockpit differed slightly from the original *Aéronavale* aircraft. The main differences were adding the SHERLOC RWR screen left of the AN/APG-104 radar scope and the improved ILS display. After July of 1994, the 'P' also received the Martin-Baker Mk-F7 ejection seat with a French survival pack. This seat replaced the Martin-Baker Mk-F5A seat originally installed on French Crusaders. (French Navy)

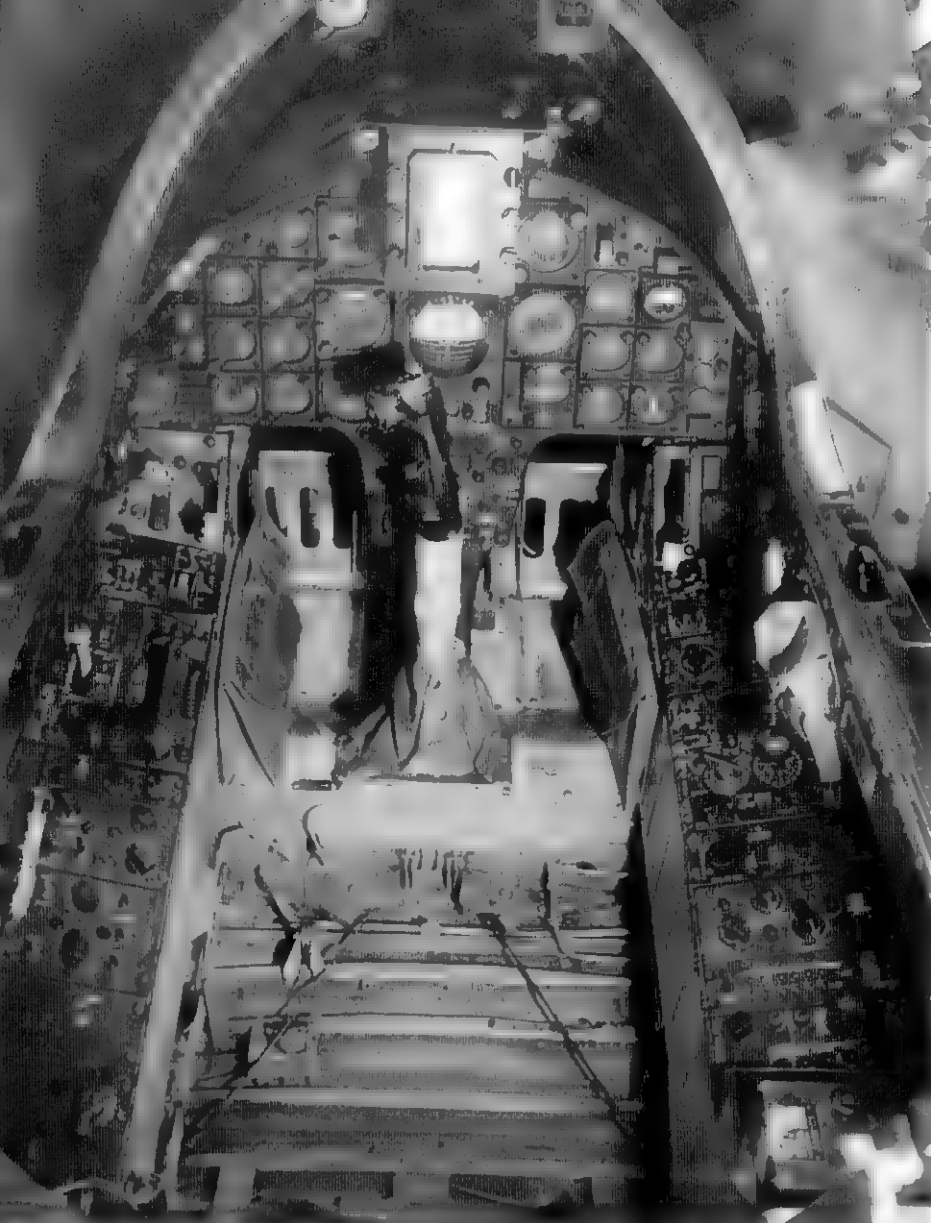
The original French Crusader's cockpit layout was basically identical to the US F-8E, except for the added BLCS controls. The F-8E (FN) had a 5-inch (12.7 cm) tall screen for the Magnavox AN/APQ-104 radar. Removal of the ejection seat exposed the intake trunk roof that formed the cockpit floor. All Crusaders had the foot well recessed in the front cockpit, which provided additional clearance for the pilot. (Gall)

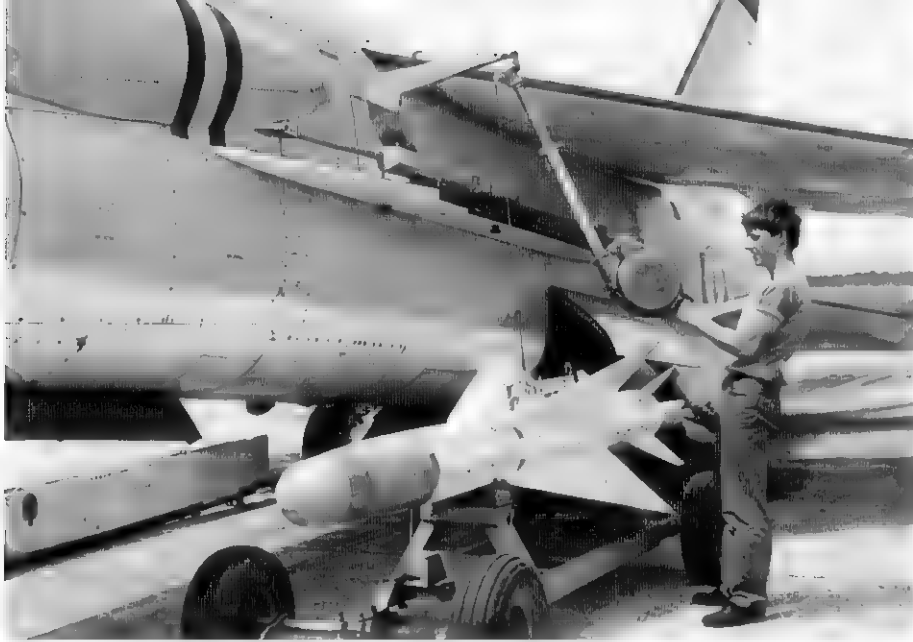
The F-8E (FN) was capable of carrying the Matra R.530 AAM, which a ground crewman is loading on this Crusader (11) using a winch fitted to the aircraft. French Crusaders carried two R.530s – one on each fuselage side. The 65 percent failure rate led the French Navy to abandon this missile in 1991. The R.530 was 11 feet 2.4 inches (3.4 m) long, 9 inches (22.9 cm) in diameter, and weighed 425 pounds (193 kg). (French Navy)

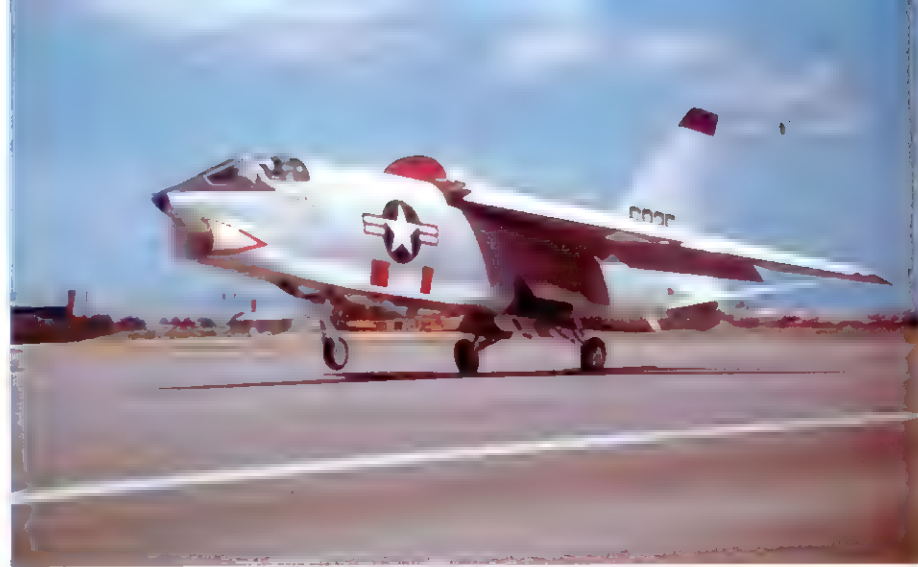
The F8U-1P (RF-8A from 18 September 1962) had squared-off fuselage sides, which provided flat surfaces for the electrically heated optical glass panels. These panels were required to yield the optimum photo quality. The flat sides were blended into the upper fuselage and curved intake air duct. Camera station 2L (2 Left) was located on the forward left fuselage. Station 3 was placed aft of 2L on the lower left fuselage. Red covers are placed over the camera windows for this test flight. (Vought)

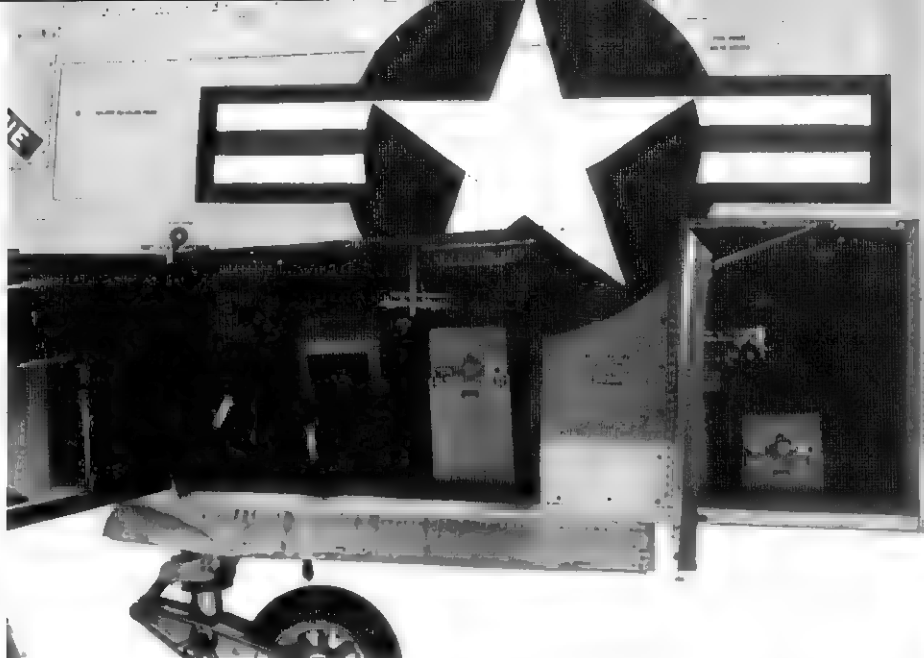
Access doors are open on stations 2 (left of picture) and 3 on the lower left fuselage of this early RF-8A. The forward-hinged doors allowed technicians to easily remove and replace cameras and film magazines. The rectangular In-flight Refueling Probe (IRP) door is located immediately above stations 2 and 3. (US Navy)
